INTERMOUNTAIN POWER PROJECT  
INTERMOUNTAIN GENERATING STATION

CONDENSER RETUBING STUDY

BLACK & VEATCH PROJECT 09255  
FILE NO. 09255.42.2604

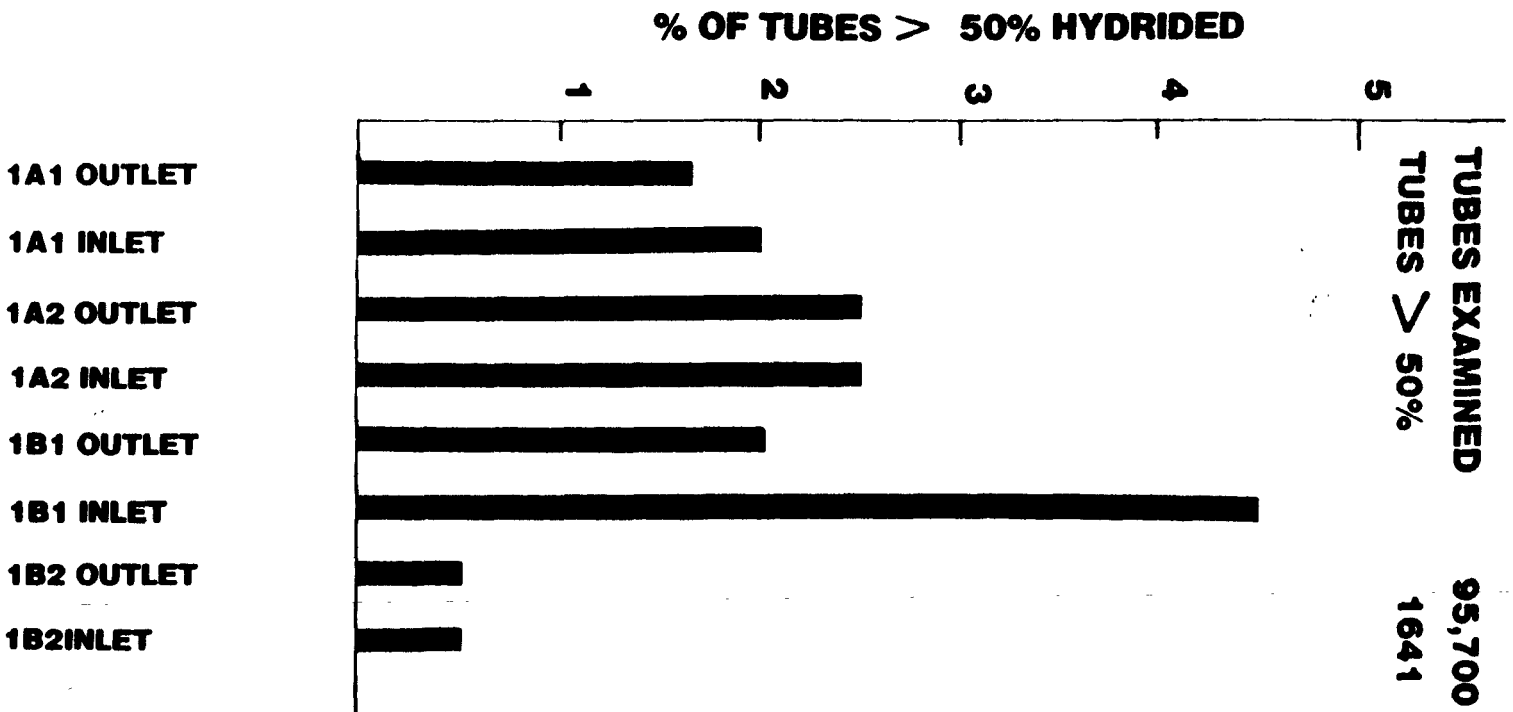
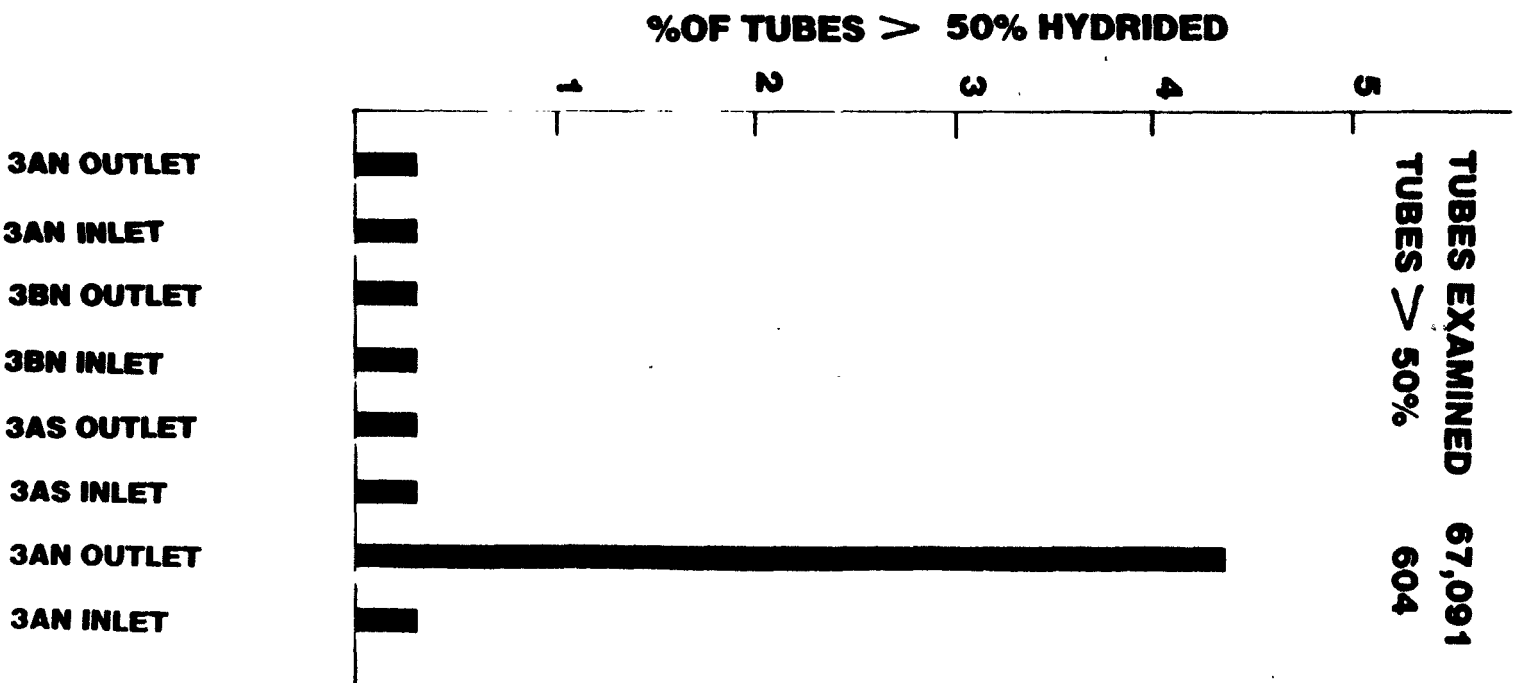
**Figure 1**

**PSL UNIT # 1**

**PTN UNIT # 3**

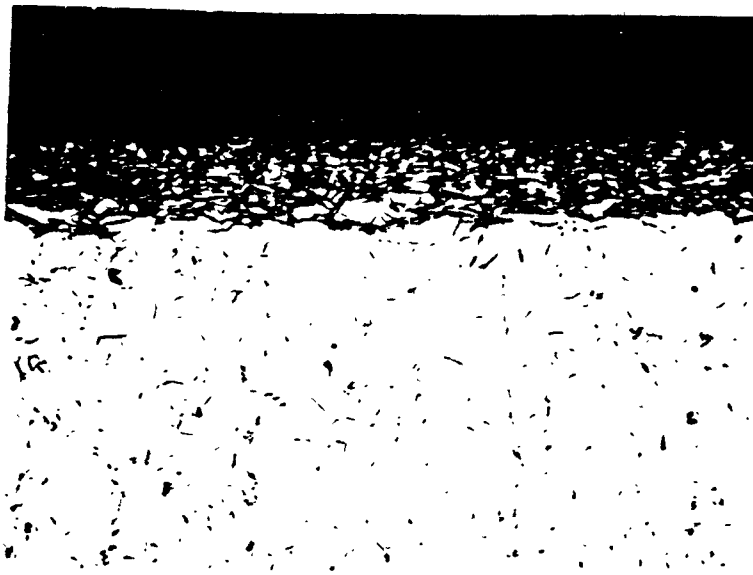
A. Located 1 inch steamside of outlet tubesheet. (200X)

Figure 2: Transverse section photomicrograph of the R78-T6 St. Lucie 1B1 tube showing I.D. surface hydride layers.

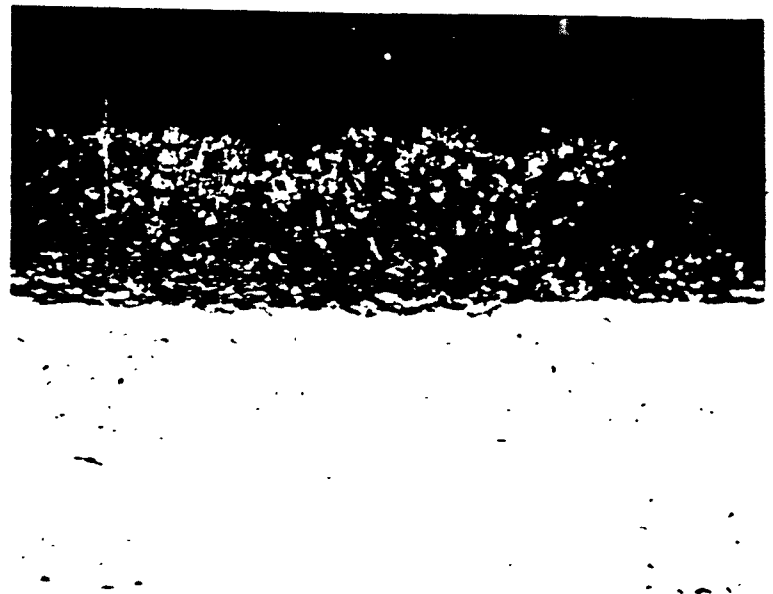
B. Located within inlet tubesheet joint. (200X)

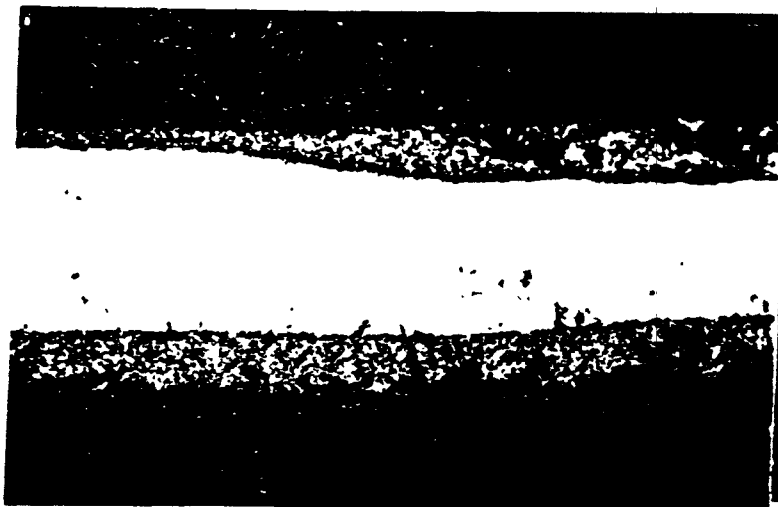
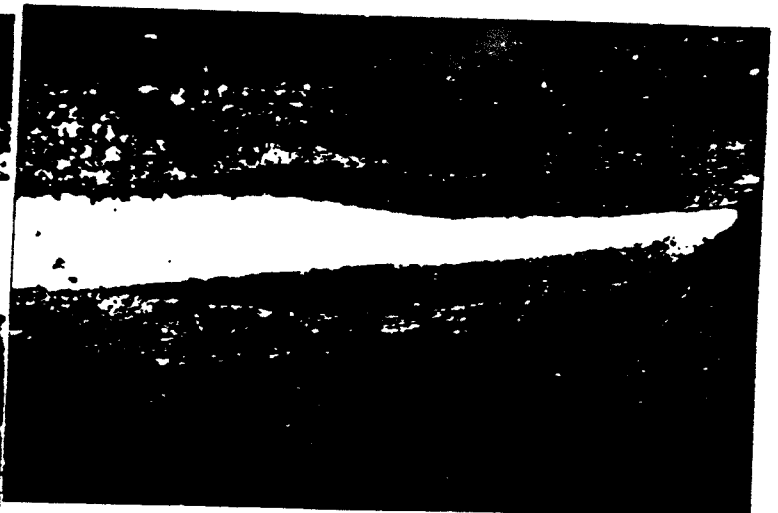
Figure 3: Longitudinal section photomicrographs of the R78-T6 St. Lucie 1B1 tube, in area up to and including the protruded outlet tube end (stub end). Note the increasing severity of I.D. and O.D. surface hydriding toward the tube end.

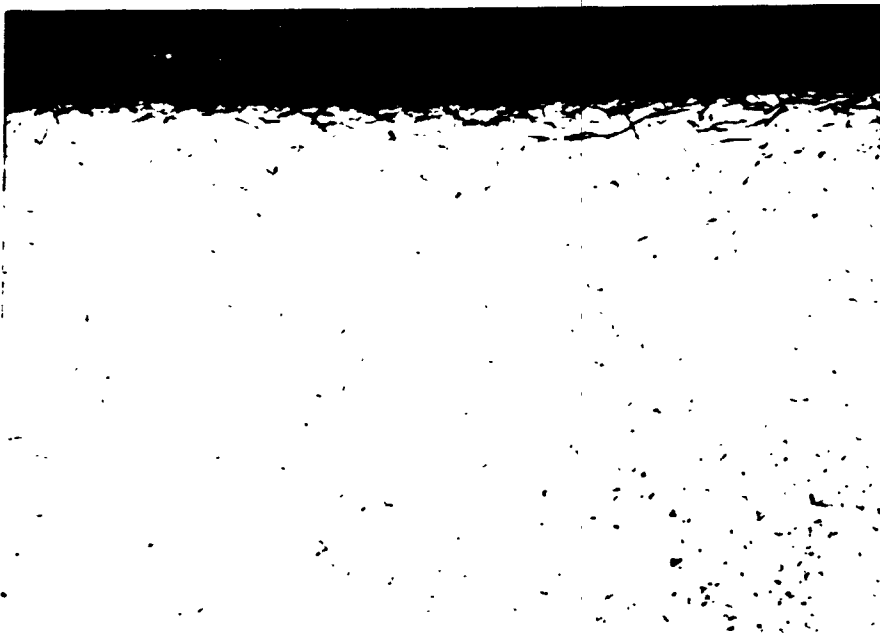
B. Located 2 feet steamside of the outlet tubesheet at 200X.

Figure 4: Section photomicrographs of the R82-T13 St. Lucie 1B1 tube, showing I. D. surface hydride layers at two locations.

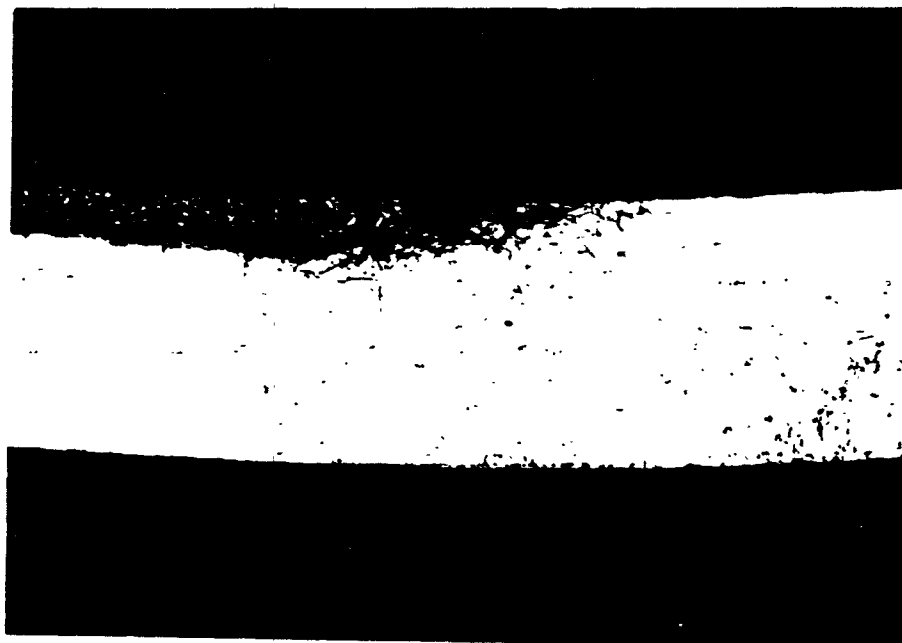
Figure 5: Transverse section photomicrograph of the R308-T1 Turkey Pt. 3A-North tube at an area several inches steamside of the outlet tubesheet. Note the I.D. surface hydride layer in tube base and HAZ metal (left to center) and its absence in the weld metal (to the right).

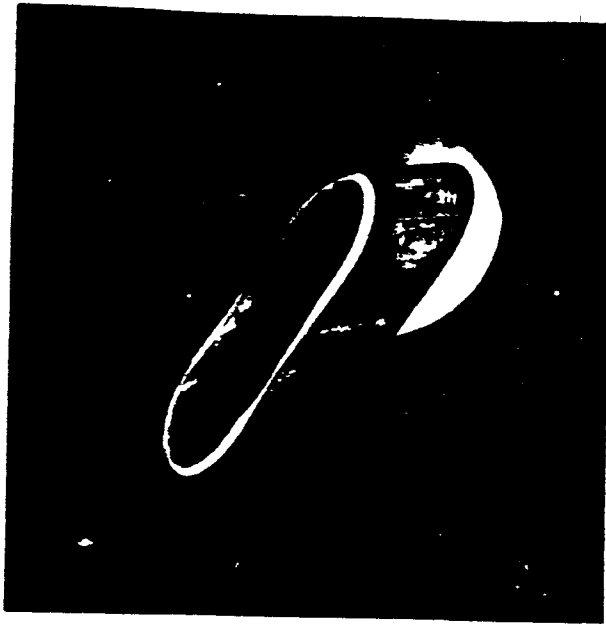
A. Typical flattened hydrided tube sample, showing no O.D. surface cracking.

Figure 6: Flattening test results for severely hydrided tube samples. Note crack arrest at the hydride layer - tube metal interface.
